Hyundai i20 2010-2012 1.2 Sportz

KA03MR4771 Reg. No

Summary

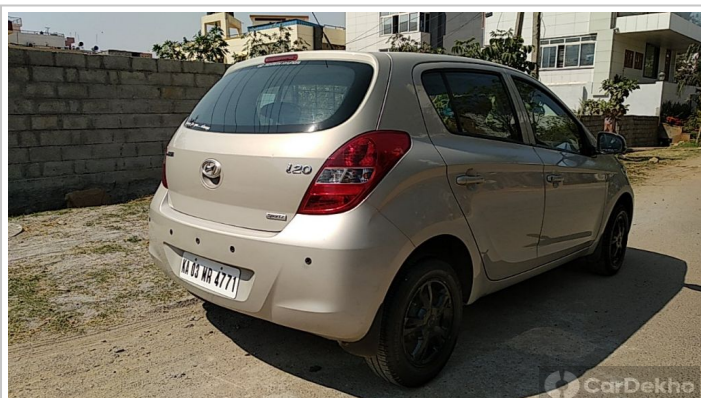
Right Quarter Panel

- ✓ A Pillar Left : Good
- ✓ B Pillar Right : Good
- ✓ Front Panel (Crossmember) : Good
- ✓ Quarter Panel Robotic Punches Original : Yes
- ✓ Running Board Left : Good
- ✓ Roof Quality : Good
- ✓ A Pillar Right : Good
- ✓ C Pillar Left : Good
- ✓ Quarter Panel Left : Good
- ✓ Apron Left : Good
- ✗ Running Board Right : Dented
- ✓ Dickey Floor : Good
- ✓ B Pillar Left : Good
- ✓ C Pillar Right : Good
- ✗ Quarter Panel Right : Scratched
- ✓ Apron Right : Good
- ✓ Running Board Robotic Punches Original : Yes
