Hyundai Grand i10 2013-2016 AT Asta

| Andheri RTO | MH02EE0406 Reg. No |

Summary

Overall Score 9 /10

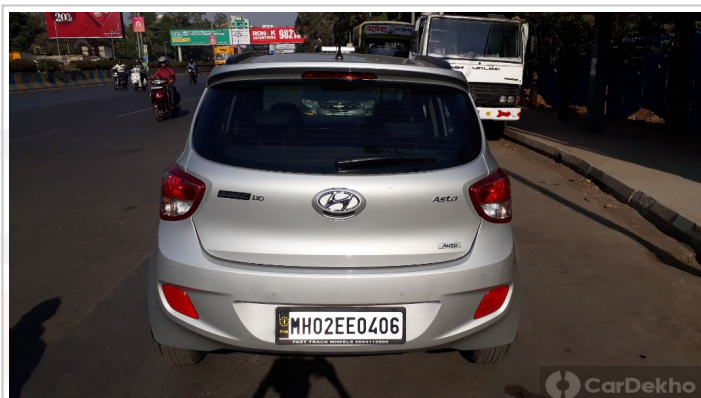
Rear (bumper, dicky door, rr-windshield, tail lights)

- ✓ Bonnet Quality : Repainted
- ✓ Dickey Door : Good
- ✓ Rear Door Right : Good
- ✓ Rear Bumper : Repainted
- ✓ Rear door glass Right : Good
- ✓ Quarter panel glass Left : Good
- ✓ ORVM Right Availability : Available
- ✓ Fender Left : Good
- ✓ Front Door Right : Good
- ✓ Rear Door Left : Good
- ✓ Front door glass Right : Good
- ✓ Rear door glass Left : Good
- ✓ Front Windscreen : Good
- ✓ ORVM Left Availability : Available
- ✓ Fender Right : Good
- ✓ Front Door Left : Good
- ✓ Front Bumper : Repainted
- ✓ Front door glass Left : Good
- ✓ Quarter panel glass Right : Good
- ✓ Rear Windscreen : Good

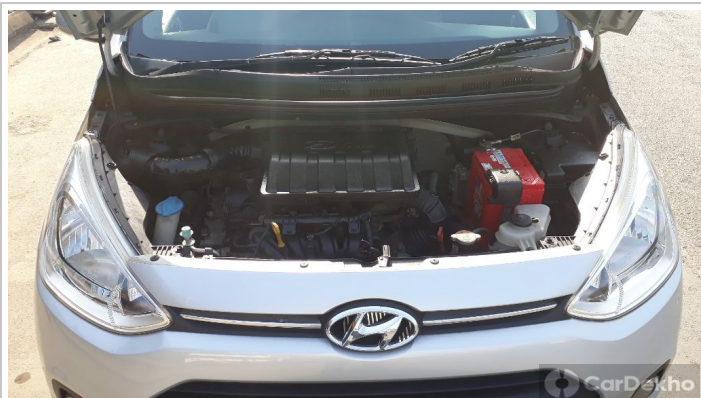
Engine Compartment

- ✓ Physical outer condition : Clean
- ✓ Engine Oil Level : Satisfactory
- ✓ Engine Coolant Quality : Clean
- ✓ Engine Exhaust Emission : Colourless
- ✓ Gear Shifting mechanism performance : Smooth
- ✓ Engine Mountings : Good
- ✓ Engine Oil Quality : Clean
- ✓ Radiator : Good
- ✓ Pick up acceleration response : Satisfactory
- ✓ Engine Sound : Normal
- ✓ Engine Coolant Level : Satisfactory
- ✓ Radiator Fan : Working
- ✓ Gear box sound : Normal

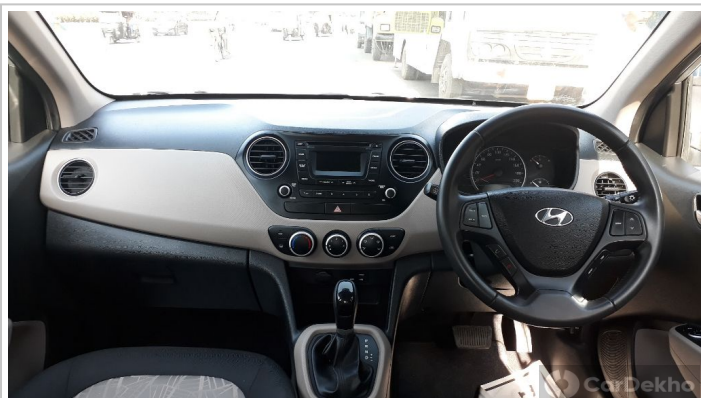
- ✓ Dashboard : Good
- ✓ Blower : Satisfactory
- ✓ Rear door glass operation Left : Working
- ✓ Front door glass operation Right : Working
- ✓ Rear door glass operation Right : Working
- ✓ Music system : Working
- ✓ Front door glass operation Left : Working
- ✓ Heater : Working

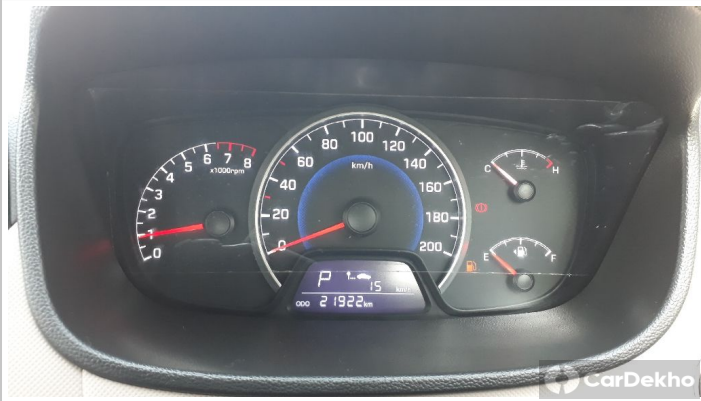
Odometer Reading (with engine on from driver seat)

| 1 No of Owners | 21922 Odometer Reading # |
