## Hyundai Grand i10 1.2 Kappa Magna AT

DL9CAN6202  
Reg. No

### Summary

**Overall Score 9.5 /10**

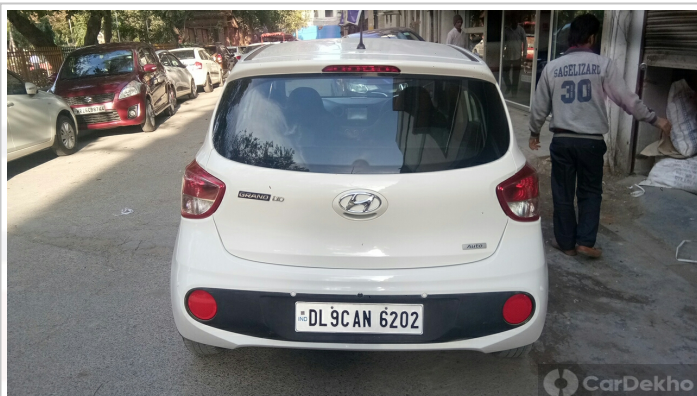
Rear (bumper, dicky door, rr-windshield, tail lights)

- ✓ Bonnet Quality : Good
- ✓ Dickey Door : Good
- ✓ Rear Door Right : Good
- ✓ Rear Bumper : Repainted
- ✓ Rear door glass Right : Good
- ✓ Quarter panel glass Left : Good
- ✓ ORVM Right Availability : Available
- ✓ Fender Left : Good
- ✓ Front Door Right : Good
- ✓ Rear Door Left : Good
- ✓ Front door glass Right : Good
- ✓ Rear door glass Left : Good
- ✓ Front Windscreen : Good
- ✓ ORVM Left Availability : Available
- ✓ Fender Right : Good
- ✓ Front Door Left : Good
- ✓ Front Bumper : Repainted
- ✓ Front door glass Left : Good
- ✓ Quarter panel glass Right : Good
- ✓ Rear Windscreen : Good
