Honda Mobilio V i-VTEC

**HR51BB5068**
Reg. No

Summary

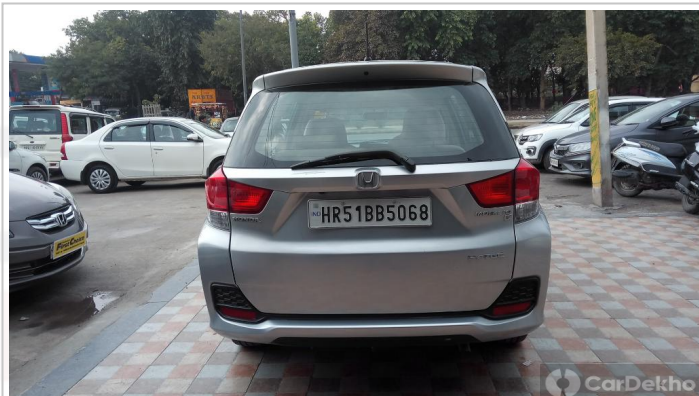
Rear (bumper, dicky door, rr-windshield, tail lights)

- ✓ Bonnet Quality : Good
- ✓ Dickey Door : Good
- ✓ Rear Door Right : Good
- ✓ Rear Bumper : Repainted
- ✓ Rear door glass Right : Good
- ✓ Quarter panel glass Left : Good
- ✓ ORVM Right Availability : Available
- ✓ Fender Left : Good
- ✓ Front Door Right : Good
- ✓ Rear Door Left : Good
- ✓ Front door glass Right : Good
- ✓ Rear door glass Left : Good
- ✓ Front Windscreen : Good
- ✓ ORVM Left Availability : Available
- ✓ Fender Right : Good
- ✓ Front Door Left : Good
- ✓ Front Bumper : Repainted
- ✓ Front door glass Left : Good
- ✓ Quarter panel glass Right : Good
- ✓ Rear Windscreen : Good
