## Tata Manza Aqua Safire

MH14EU3145 Reg. No

### Summary

**Overall Score 8.5 /10**

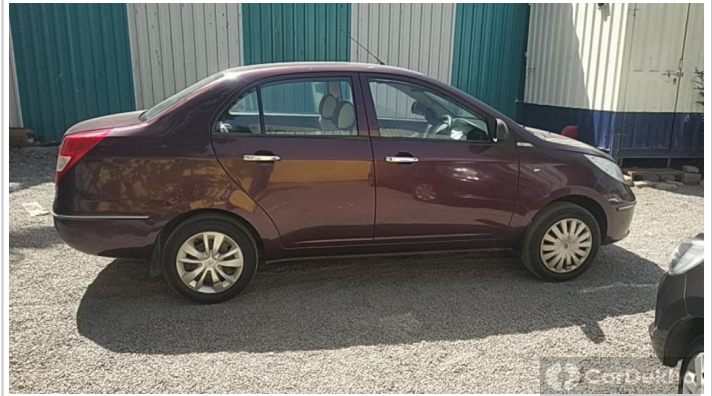
Right Side (fender, doors, qtr panel)

- ✓ Bonnet Quality : Good
- ✓ Dickey Door : Good
- ✗ Rear Door Right : Scratched
- ✓ Rear Bumper : Good
- ✓ Rear door glass Right : Good
- ✓ Quarter panel glass Left : Good
- ✓ ORVM Right Availability : Available
- ✓ Fender Left : Good
- ✓ Front Door Right : Good
- ✓ Rear Door Left : Good
- ✓ Front door glass Right : Good
- ✓ Rear door glass Left : Good
- ✓ Front Windscreen : Good
- ✓ ORVM Left Availability : Available
- ✓ Fender Right : Good
- ✓ Front Door Left : Good
- ✓ Front Bumper : Good
- ✓ Front door glass Left : Good
- ✓ Quarter panel glass Right : Good
- ✓ Rear Windscreen : Good
