## Hyundai Grand i10 2013-2016 CRDi Era

KA53MA9545 Reg. No

### Summary

**Overall Score 8.5 /10**

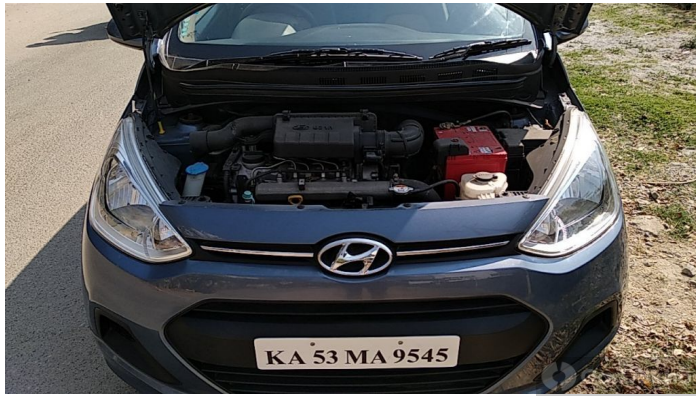
Engine Compartment

- ✓ Physical outer condition : Clean
- ✓ Engine Oil Level : Satisfactory
- ✓ Engine Coolant Quality : Clean
- ✓ Engine Exhaust Emission : Colourless
- ✓ Gear Shifting mechanism performance : Smooth
- ✓ Engine Mountings : Good
- ✓ Engine Oil Quality : Clean
- ✓ Radiator : Good
- ✓ Pick up acceleration response : Satisfactory
- ✓ Engine Sound : Normal
- ✓ Engine Coolant Level : Satisfactory
- ✓ Radiator Fan : Working
- ✓ Gear box sound : Normal
