## Maruti Alto LXi

**MH11AW4291**  
Reg. No

### Summary

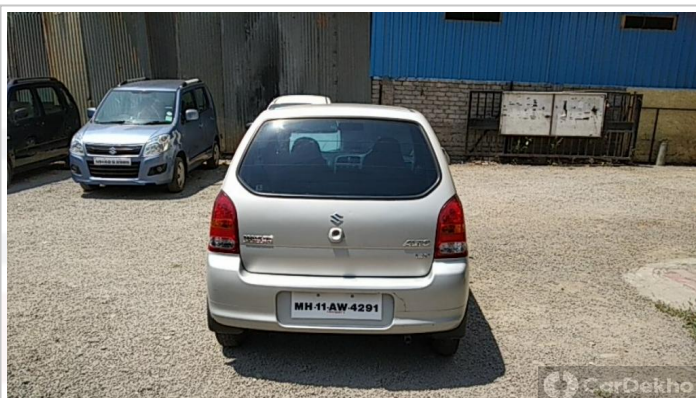
Rear (bumper, dicky door, rr-windshield, tail lights)

- ✓ Bonnet Quality : Repainted, Repaired
- ✓ Dickey Door : Good
- ✓ Rear Door Right : Good
- ✓ Rear Bumper : Repainted, Cracked
- ✓ Rear door glass Right : Good
- ✓ Rear Windscreen : Good
- ✓ Fender Left : Good
- ✓ Front Door Right : Good
- ✓ Rear Door Left : Good
- ✓ Front door glass Right : Good
- ✓ Rear door glass Left : Good
- ✓ ORVM Right Availability : Available
- ✓ Fender Right : Good
- ✓ Front Door Left : Good
- ✓ Front Bumper : Repainted, Cracked
- ✓ Front door glass Left : Good
- ✓ Front Windscreen : Good
- ✓ ORVM Left Availability : Available

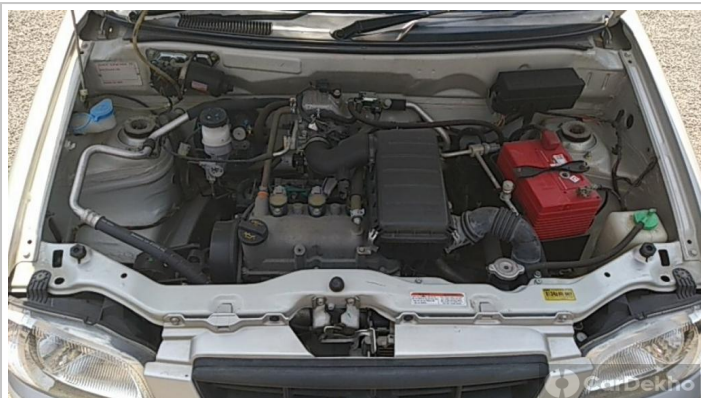
Engine Compartment

- ✓ Physical outer condition : Clean
- ✓ Engine Oil Level : Satisfactory
- ✓ Engine Coolant Quality : Clean
- ✓ Engine Exhaust Emission : Colourless
- ✓ Gear Shifting mechanism performance : Smooth
- ✓ Engine Mountings : Good
- ✓ Engine Oil Quality : Clean
- ✓ Radiator : Good
- ✓ Pick up acceleration response : Satisfactory
- ✓ Engine Sound : Normal
- ✓ Engine Coolant Level : Satisfactory
- ✓ Radiator Fan : Working
- ✓ Gear box sound : Normal

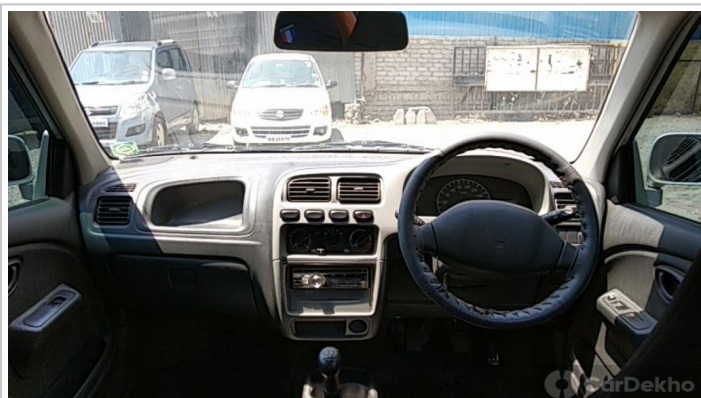
- ✓ Dashboard : Good
- ✓ Blower : Satisfactory
- ✓ Rear door glass operation Left : Working
- ✓ Front door glass operation Right : Working
- ✓ Rear door glass operation Right : Working
- ✓ Music system : Working
- ✓ Front door glass operation Left : Working
- ✓ Heater : Working
