Honda WRV 2017-2020 i-VTEC S

**MH09EK2563**
Reg. No

Summary		Overall Score 9 /10	
Body and Frame	10 /10	Exterior Details	9 /10
Interior Details	9 /10	Engine and Transmission	9 /10
Electricals	10 /10	Light	10 /10
Tyre	6.5 /10	Other Details	10 /10

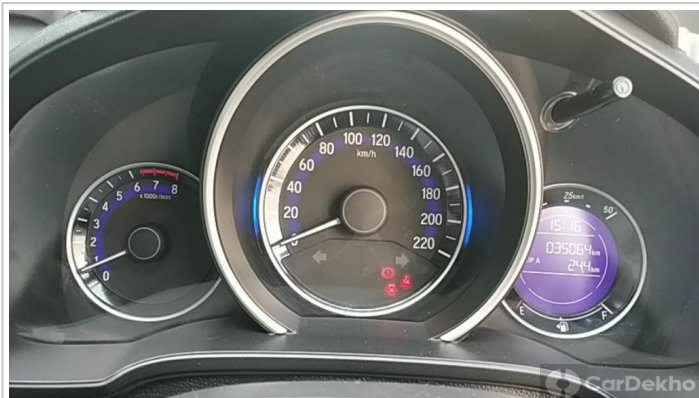
Odometer Reading (with engine on from driver seat)

**35064**
Odometer Reading #
