Renault KWID 2015-2019 1.0

MH12RR1294 Reg. No

Summary

Overall Score 9.5 /10

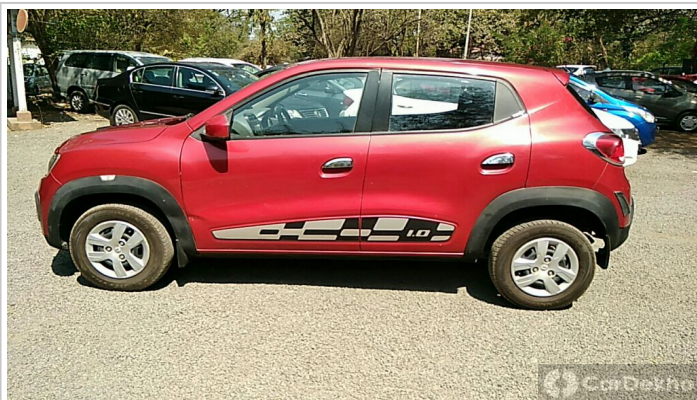
Left Side (fender, doors, qtr Panel)

- ✓ Bonnet Quality : Good
- ✓ Dickey Door : Good
- ✓ Rear Door Right : Good
- ✓ Rear Bumper : Good
- ✓ Rear door glass Right : Good
- ✓ Quarter panel glass Left : Good
- ✓ ORVM Right Availability : Available
- ✓ Fender Left : Good
- ✓ Front Door Right : Good
- ✗ Rear Door Left : Scratched
- ✓ Front door glass Right : Good
- ✓ Rear door glass Left : Good
- ✓ Front Windscreen : Good
- ✓ ORVM Left Availability : Available
- ✓ Fender Right : Good
- ✓ Front Door Left : Good
- ✓ Front Bumper : Good
- ✓ Front door glass Left : Good
- ✓ Quarter panel glass Right : Good
- ✓ Rear Windscreen : Good
