Mahindra Verito Vibe 1.5 dCi D6

MH48P7853 Reg. No

Summary		Overall Score 9 /10	
Body and Frame	10 /10	Exterior Details	8 /10
Interior Details	8 /10	Engine and Transmission	8 /10
Electricals	10 /10	Light	10 /10
Tyre	6.5 /10	Other Details	10 /10

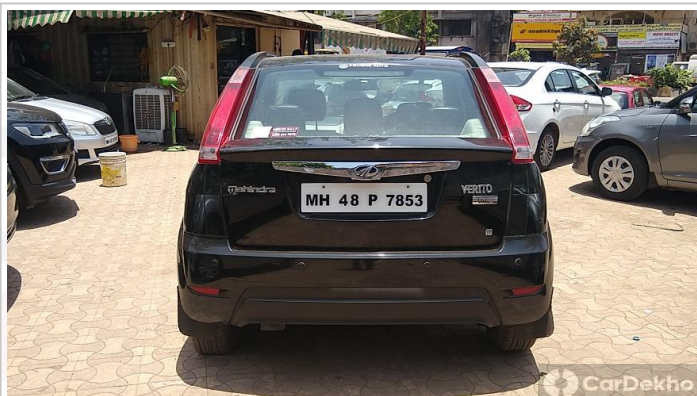
Rear (bumper, dicky door, rr-windshield, tail lights)

- ✓ Bonnet Quality : Good
- ✓ Dickey Door : Good
- ✓ Rear Door Right : Good
- ✓ Rear Bumper : Repainted
- ✓ Rear door glass Right : Good
- ✓ Quarter panel glass Left : Good
- ✓ ORVM Right Availability : Available
- ✓ Fender Left : Good
- ✓ Front Door Right : Good
- ✓ Rear Door Left : Good
- ✓ Front door glass Right : Good
- ✓ Rear door glass Left : Good
- ✓ Front Windscreen : Replaced
- ✓ ORVM Left Availability : Available
- ✓ Fender Right : Good
- ✓ Front Door Left : Good
- ✓ Front Bumper : Repainted
- ✓ Front door glass Left : Good
- ✓ Quarter panel glass Right : Good
- ✓ Rear Windscreen : Good
