Honda City 2015-2017 i VTEC S

**MH02DZ3918**
Reg. No

Summary

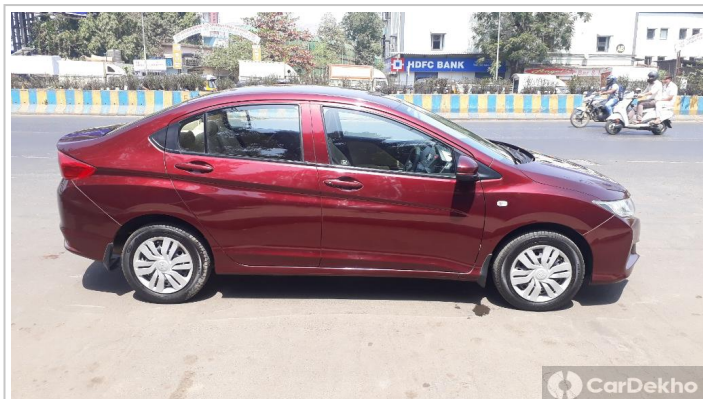
Right Side (fender, doors, qtr panel)

- ✓ Bonnet Quality : Repainted
- ✓ Dickey Door : Repainted, Dented
- ✓ Rear Door Right : Repainted
- ✓ Rear Bumper : Repainted
- ✓ Rear door glass Right : Good
- ✓ Quarter panel glass Left : Good
- ✓ ORVM Right Availability : Available
- ✓ Fender Left : Repainted
- ✓ Front Door Right : Repainted
- ✓ Rear Door Left : Repainted
- ✓ Front door glass Right : Good
- ✓ Rear door glass Left : Good
- ✓ Front Windscreen : Good
- ✓ ORVM Left Availability : Available
- ✓ Fender Right : Repainted
- ✓ Front Door Left : Repainted
- ✓ Front Bumper : Repainted
- ✓ Front door glass Left : Good
- ✓ Quarter panel glass Right : Good
- ✓ Rear Windscreen : Good

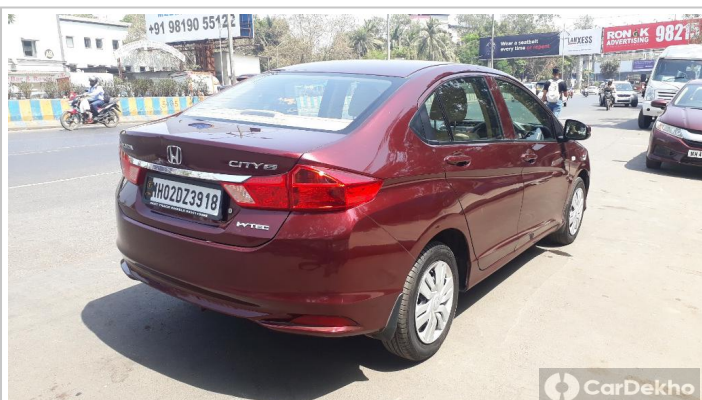
Right Quarter Panel

- ✓ A Pillar Left : Good
- ✓ B Pillar Right : Good
- ✓ Front Panel (Crossmember) : Good
- ✓ Quarter Panel Robotic Punches Original : Yes
- ✓ Running Board Left : Repainted
- ✓ Roof Quality : Good
- ✓ A Pillar Right : Good
- ✓ C Pillar Left : Good
- ✓ Quarter Panel Left : Repainted
- ✓ Apron Left : Good
- ✓ Running Board Right : Repainted
- ✓ Dickey Floor : Good
- ✓ B Pillar Left : Good
- ✓ C Pillar Right : Good
- ✓ Quarter Panel Right : Repainted
- ✓ Apron Right : Good
- ✓ Running Board Robotic Punches Original : Yes

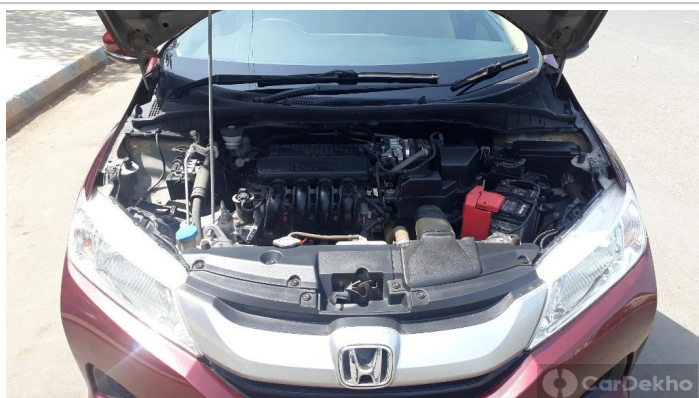
Engine Compartment

- ✓ Physical outer condition : Clean
- ✓ Engine Oil Level : Satisfactory
- ✓ Engine Coolant Quality : Clean
- ✓ Engine Exhaust Emission : Colourless
- ✓ Gear Shifting mechanism performance : Smooth
- ✓ Engine Mountings : Good
- ✓ Engine Oil Quality : Clean
- ✓ Radiator : Good
- ✓ Pick up acceleration response : Satisfactory
- ✓ Engine Sound : Normal
- ✓ Engine Coolant Level : Satisfactory
- ✓ Radiator Fan : Working
- ✓ Gear box sound : Normal
