Honda City 4th Generation i-VTEC S

**MH14FG4932**
Reg. No

Summary

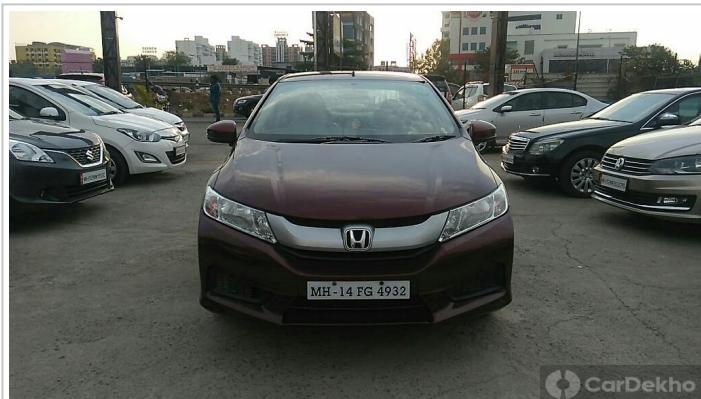
Front View (bumper, bonnet, fr-windshield, headlights, grill)

- ✗ Bonnet Quality : Dented
- ✓ Dickey Door : Good
- ✓ Rear Door Right : Good
- ✓ Rear Bumper : Good
- ✓ Rear door glass Right : Good
- ✓ Rear Windscreen : Good
- ✓ Fender Left : Good
- ✓ Front Door Right : Good
- ✓ Rear Door Left : Good
- ✓ Front door glass Right : Good
- ✓ Rear door glass Left : Good
- ✓ ORVM Right Availability : Available
- ✓ Fender Right : Good
- ✓ Front Door Left : Good
- ✓ Front Bumper : Good
- ✓ Front door glass Left : Good
- ✓ Front Windscreen : Good
- ✓ ORVM Left Availability : Available

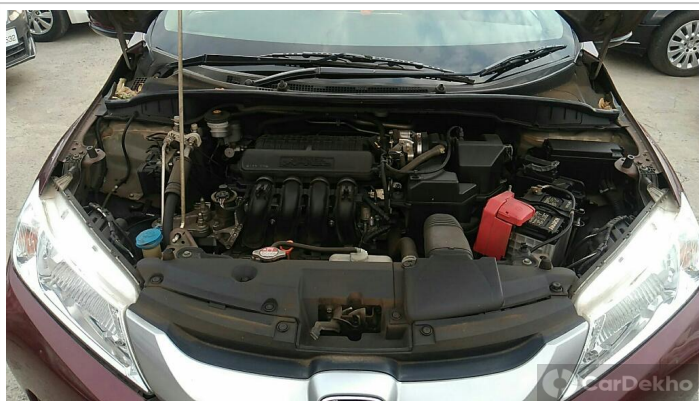
Engine Compartment

- ✓ Physical outer condition : Clean
- ✓ Engine Oil Level : Satisfactory
- ✓ Engine Coolant Quality : Clean
- ✓ Engine Exhaust Emission : Colourless
- ✓ Gear Shifting mechanism performance : Smooth
- ✓ Engine Mountings : Good
- ✓ Engine Oil Quality : Clean
- ✓ Radiator : Good
- ✓ Pick up acceleration response : Satisfactory
- ✓ Engine Sound : Normal
- ✓ Engine Coolant Level : Satisfactory
- ✓ Radiator Fan : Working
- ✓ Gear box sound : Normal
