Maruti Baleno 2015-2022 1.3 Alpha

HR26DG6180 Reg. No

Overall Score 9.5 /10

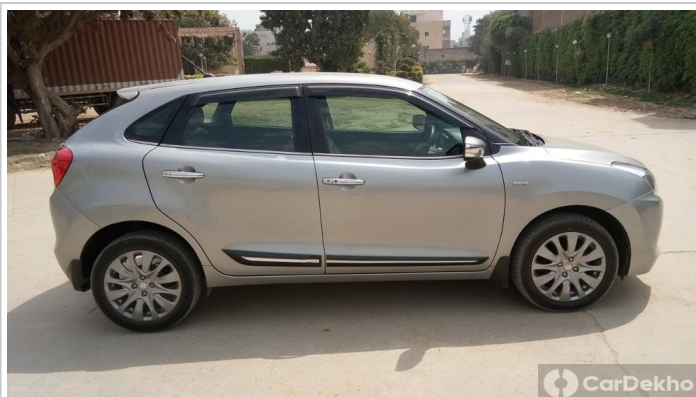
Right Side (fender, doors, qtr panel)

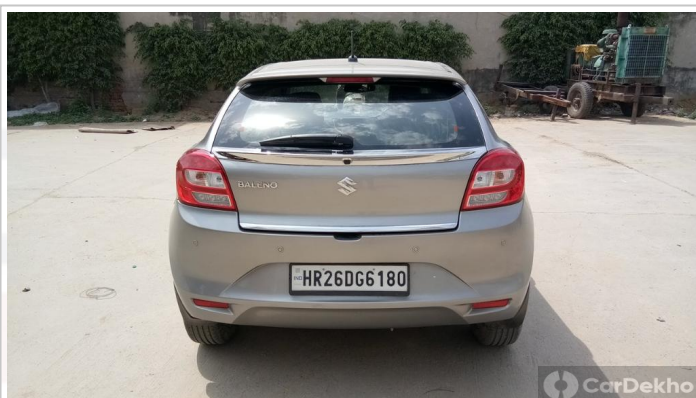
Rear (bumper, dicky door, rr-windshield, tail lights)

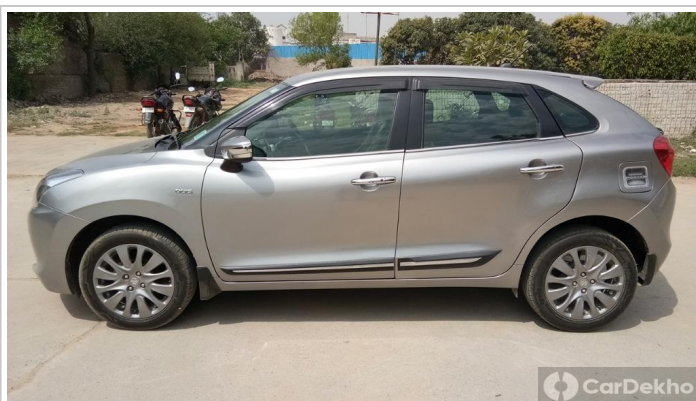
Left Side (fender, doors, qtr Panel)
