Honda City 2015-2017 i VTEC S

**MH02DZ3918**
Reg. No

Summary

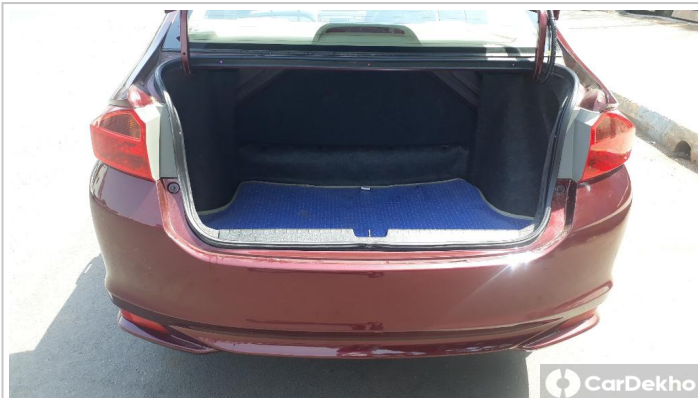
Boot / Dicky

- ✓ Bonnet Quality : Repainted
- ✓ Dickey Door : Repainted, Dented
- ✓ Rear Door Right : Repainted
- ✓ Rear Bumper : Repainted
- ✓ Rear door glass Right : Good
- ✓ Quarter panel glass Left : Good
- ✓ ORVM Right Availability : Available
- ✓ Fender Left : Repainted
- ✓ Front Door Right : Repainted
- ✓ Rear Door Left : Repainted
- ✓ Front door glass Right : Good
- ✓ Rear door glass Left : Good
- ✓ Front Windscreen : Good
- ✓ ORVM Left Availability : Available
- ✓ Fender Right : Repainted
- ✓ Front Door Left : Repainted
- ✓ Front Bumper : Repainted
- ✓ Front door glass Left : Good
- ✓ Quarter panel glass Right : Good
- ✓ Rear Windscreen : Good
